SCRUTINEER'S BULLETIN

March 2019 (160)

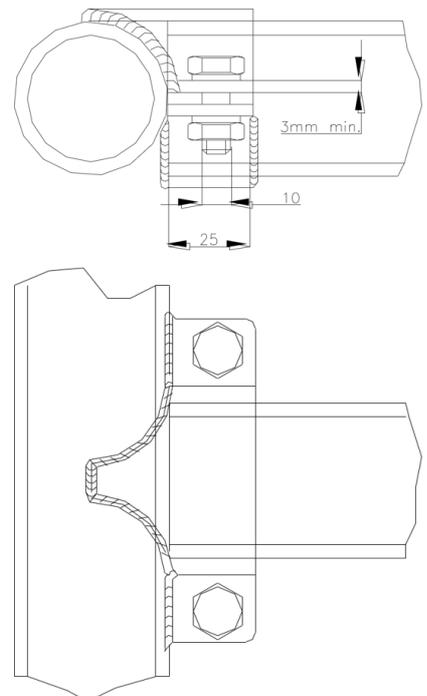
The first 2 photos below were forwarded on to us by a concerned Scrutineer who encountered this ROPS fitted in car presented for inspection. The Scrutineer was rightly concerned about the quality and integrity of the dismantable joints used in the construction of the ROPS and rejected it on this basis.

The joint appears to be a vague attempt to follow the principle of the allowable dismantable joint in Motorsport UK Yearbook drawings (K)21-22 (or FIA drawing 253-37 shown to the right). However, it falls way below an acceptable standard for a number of reasons. The part of joint attached to the roll hoop is nowhere near being fully welded along its whole contact surface. The part of the joint

attached to the end of the tube is not welded around the 'open' end, which is related to the fact that the tube is also not flush with the edge of the joint piece, which is important as it is then not clear how much of the tube is actually being compressed by the joint once tightened. And the bolts used are clearly too short as not only are there no exposed threads through the nut as we would expect to see, but it looks as though the bolt is only turned a few threads into the nut! Each of these factors alone clearly contravenes the way the joint should be fabricated and utilised according to the drawing.

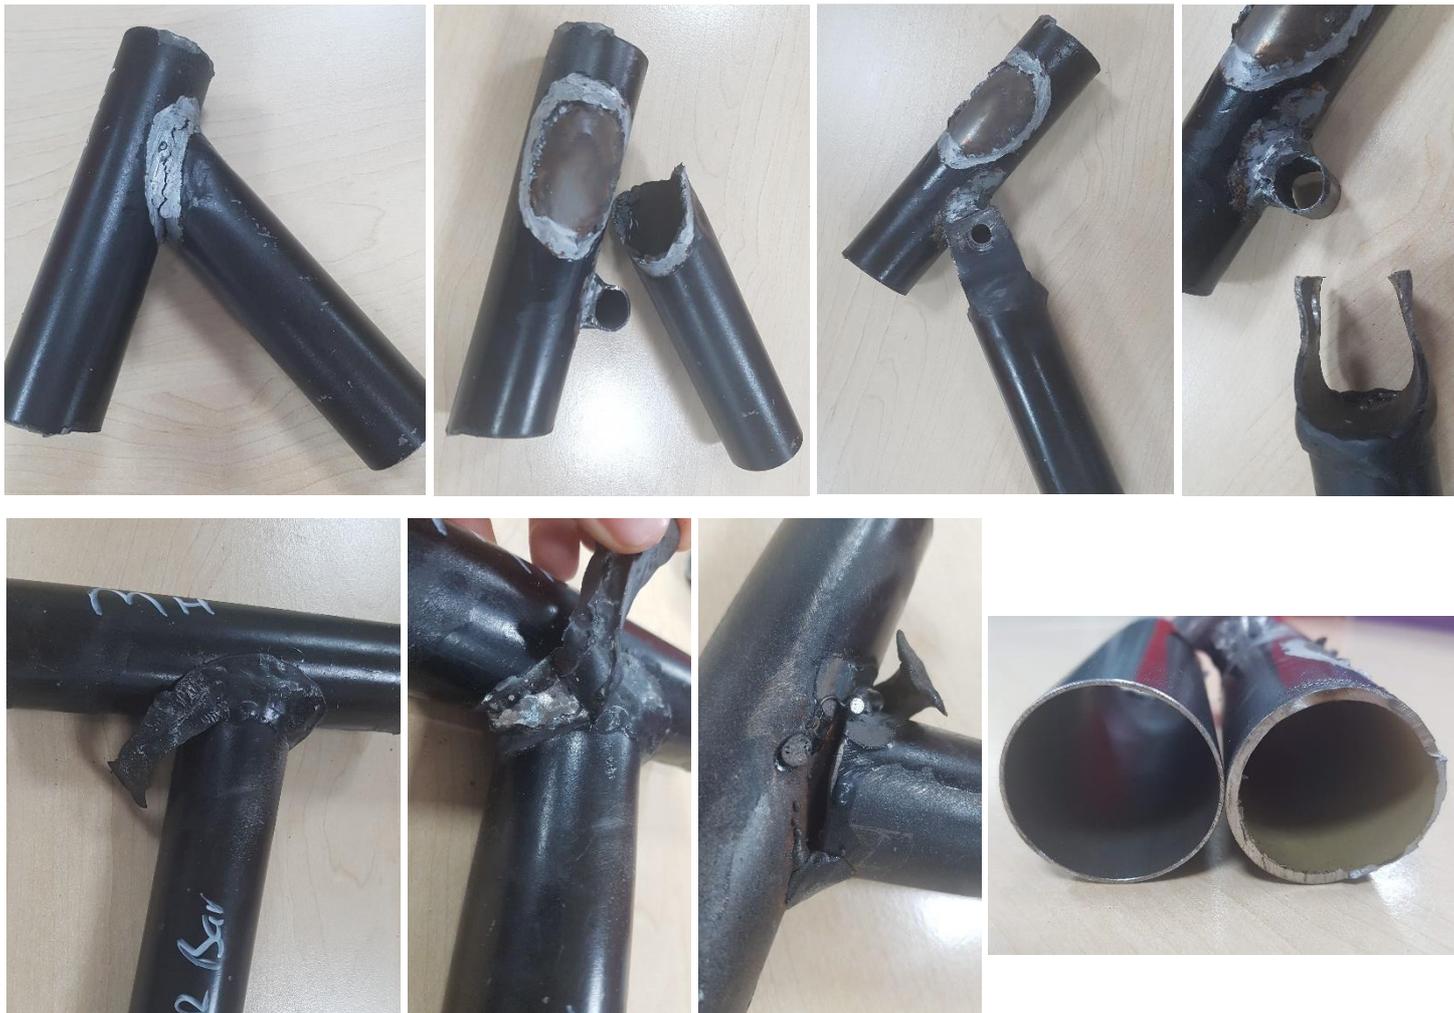
The next series of photos barely need any explanation! These examples were provided to us by a reputable ROPS manufacturer, and are taken from a ROPS (not one of theirs!) that arrived in their workshop for some work. It didn't take long to establish that something was not right and was soon clear that a number of additions had been made to what appeared to be a fairly standard main hoop – these additions were made of tube with the same outside diameter but very low wall thickness. They were also not welded anywhere near satisfactorily, with significantly incomplete welds, poor penetration and generally very messy appearance, with the one example below being verily easily pulled apart by hand. There was also a very badly fashioned dismantlable joint in use. However, perhaps the most alarming discovery was that most of these badly welded joints were covered with putty prior to painting! A reminder to look carefully and dig a little deeper if something doesn't seem quite right!

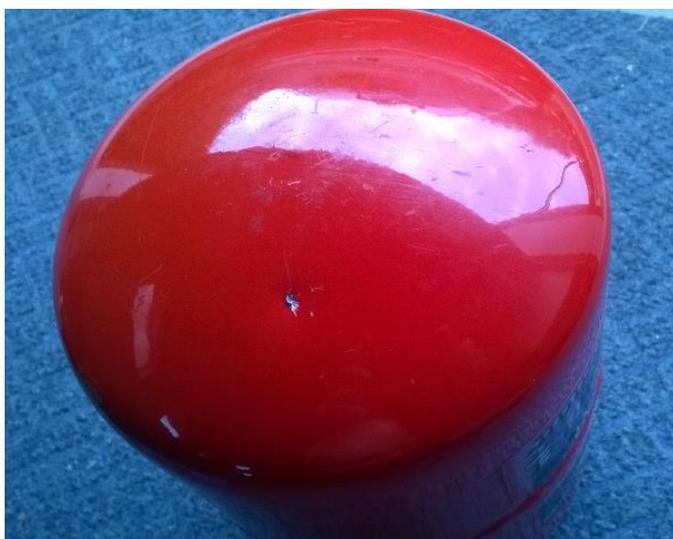
The picture of the extinguisher was sent in to us by a Scrutineer, with what appears to be minimal damage. It was found when the bottle was being serviced that the small mark on the base had caused a sharp pimple on the inside of the body causing additional pressure stretching the bladder, and the bottle was about to burst! This leads on to say that it's important to check for even the smallest amount of damage to bottles as knocks to the outside can cause damage inside also, potentially leading to serious consequences.

It is important to note that all extinguishers must be serviced in accordance to the manufacturers guidelines, or every 24 months, whichever is sooner as per (K)3. Both the condition of the extinguisher and the service label should be checked during scrutineering. We have had reports of an extinguisher with the last service date being in 2013 – the owner had taken part in 6 events in 2018!
