SCRUTINEERS' BULLETIN

June 2019 (163)

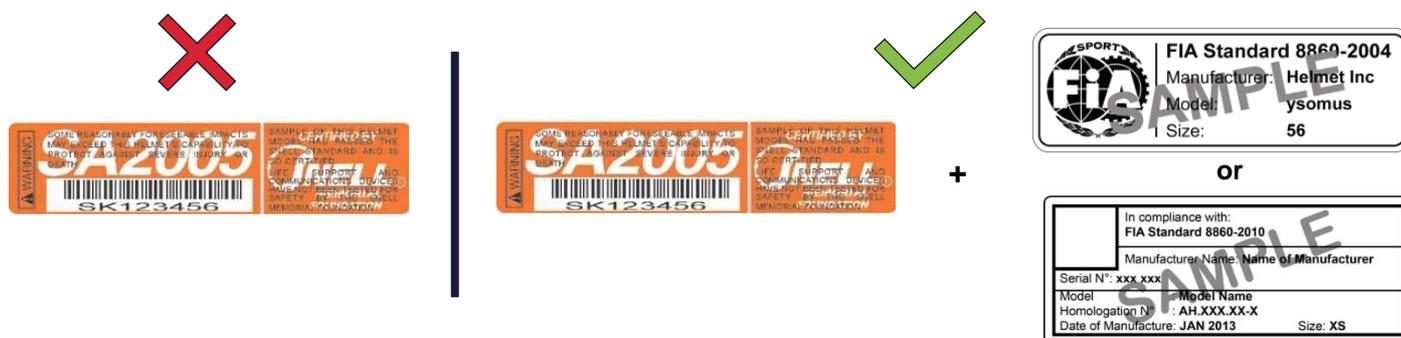
A reminder that the Snell SA2005 helmet was withdrawn from the list of accepted standards at the end of 2018; however, this does not mean that every helmet manufactured to this standard cannot be used in Motorsport UK events. Some helmets have dual standards, holding a Snell and FIA standard with both standards appearing on the helmet – if the SA2005 standard appears along with a valid FIA Standard listed in (K)10.3.1, then this helmet is valid for use in Motorsport UK events. The later FIA standard overrides the expired Snell standard, for example a helmet marked with the Snell SA2005 and FIA 8869-2004 will still be acceptable up until the end of 2020.

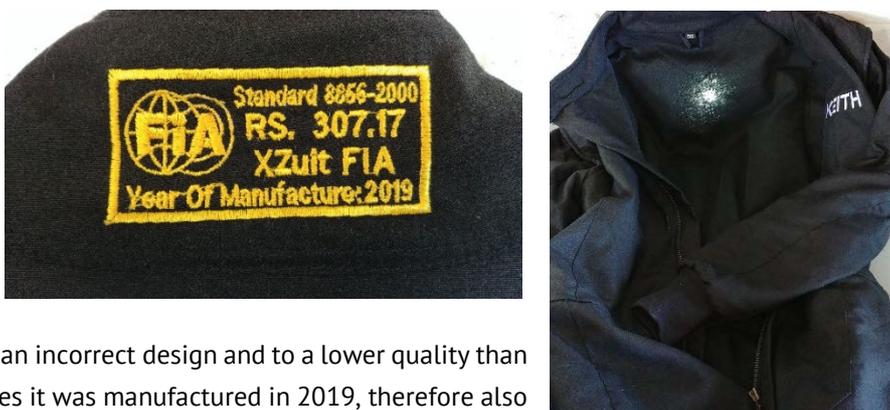
These pictures were sent in by a keen-eyed scrutineer who noticed the material used and the general build of the suit was to a poor quality.

The stitching on the collar of the suit that holds the FIA standard information and the year of manufacture in had thread linking each letter together and a general

poor standard of embroidery, the FIA logo is an incorrect design and to a lower quality than normally seen. The details on the collar states it was manufactured in 2019, therefore also missing from the suit was the FIA hologram adjacent to the zip, which is part of the latest labeling system that has been in place since 01.01.2013.

What was even more apparent was that light could be seen shining through the material on the back of the suit perhaps suggesting the incorrect material had been used in the manufacturing of the suit – additionally the cuffs of the suit appeared to be made from a nylon type material. The suit was impounded for the duration of the event and fortunately the competitor had a spare pair of overalls which were to the correct standard and in suitable condition.

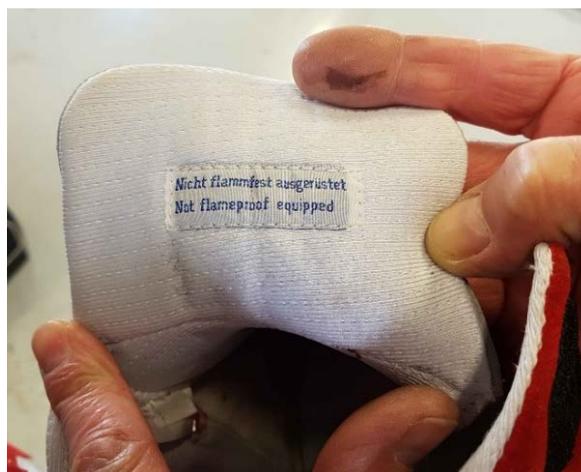
A competitor presented his boots at a recent event and the scrutineer noticed this label in the tongue of the shoe. The label that states, 'Not flameproof equipped'. Where protective shoes are required by specific regulations, the garments must be tested to ISO 6940 or a relevant FIA standard, with all fastenings and laces to be of a non-fusible material along with all threads to be flame resistant. The boots in question were impounded for the duration of the event and the competitor was able to purchase a new pair which conformed to the correct standards for flame resistant boots.

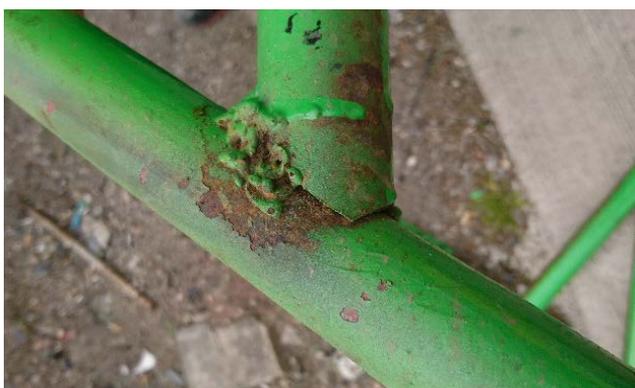
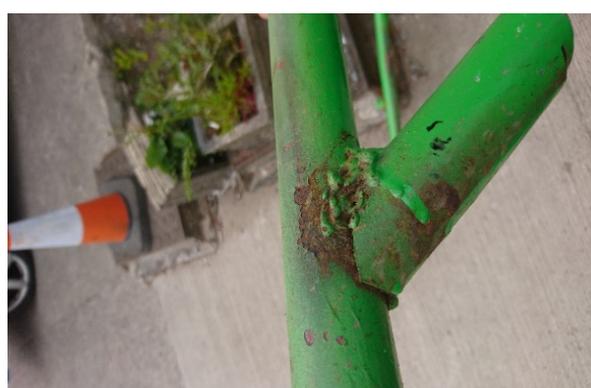
The following pictures were sent in by a scrutineer demonstrating poor workmanship on a ROPS. Not only is the welding of a poor quality, but the weld barely makes it half way around the join between the two bars and is of poor penetration – it is quite clear that if this ROPS were be in an accident it would not offer much protection. Guidance on welding can be found in section K1.3.8.

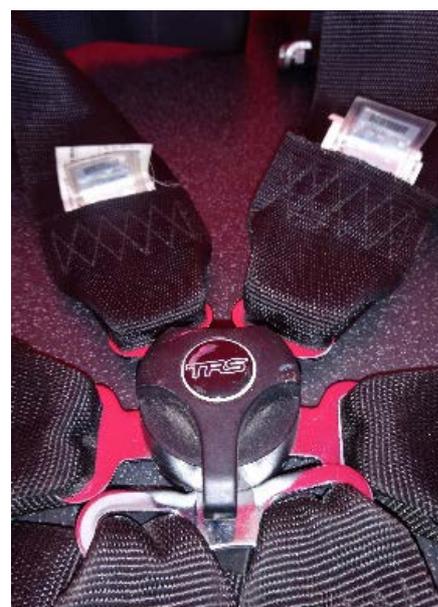
The harnesses in this photograph were sent in by a Scrutineer from a recent event at Snetterton. They were found with two labels/holograms, one on each shoulder strap, when only one should be present on the left-hand strap.

While all the straps had the same homologation number it was clear that one of the shoulder straps had been taken from another set – a reminder that it is not permitted to mix and match straps from other harnesses. The driver tried to convince the scrutineers that this is how the manufacturer returned the belts to them, however on closer inspection only the serial numbers on the lap belts matched which point the finger again at mixing straps on the harness set.
